## Rural Water Supply Assessment

**Project Report No. W-08**  
**Oct 2007**

**Muthusi F.M., Mahamud G., Abdalle A., Gadain H.M. (2007)**, Rural Water Supply Assessment, Technical Report No-08, FAO-SWALIM, Nairobi, Kenya.

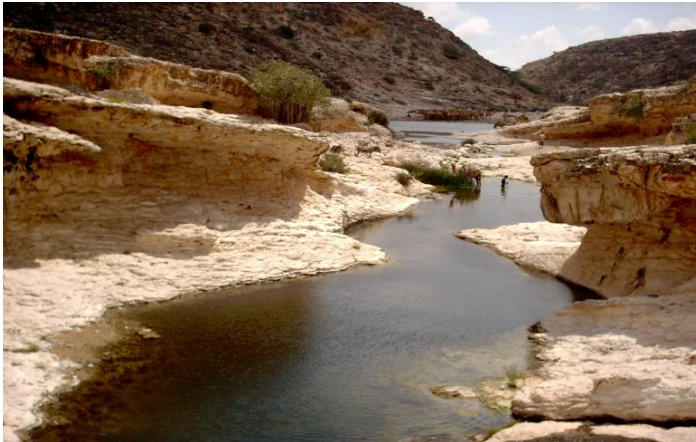
**Figure 3.1** A typical *togga* of Nugal Valley

There are several large water catchments draining the Nugal, Sanaag, Bari and Sool areas of Puntland, but there are no perennial rivers. Faillace (1986) noted that there are high mountain ranges parallel to the Gulf of Aden with numerous seasonal rivers (*toggas*) flowing either to the Gulf of Aden or southwards to the sloping plains and valleys in Nugal and Mudug regions. The main water courses are the Nugal and Danor valleys, which transverse the central and southern parts of Puntland. Water along these valleys is found immediately beneath the ground surface. One such *togga* is shown in Figure 3.1.

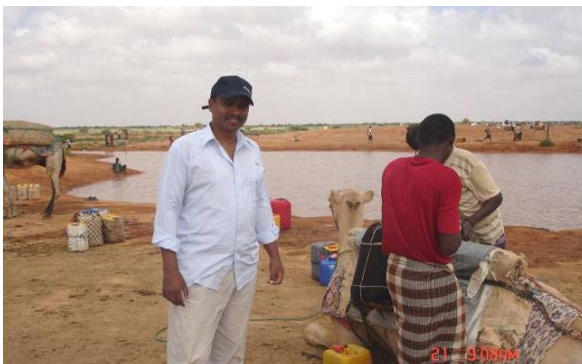
**Figure 3.2** A small *war* in Nugal Region

*War* refers to unlined dug-out, mainly 2–3 m deep with a surface area of hundreds to thousands of square meters. *Wars* are dug by an excavator, which drops the loose materials onto a wall on the downstream parts of the dug-out. Water is led by ditches to the *war*. Figure 3.2 shows a *war* in Nugal Region.

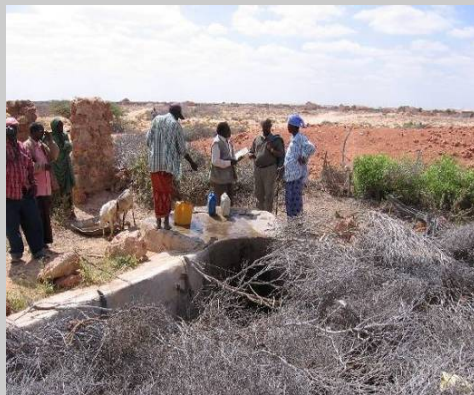
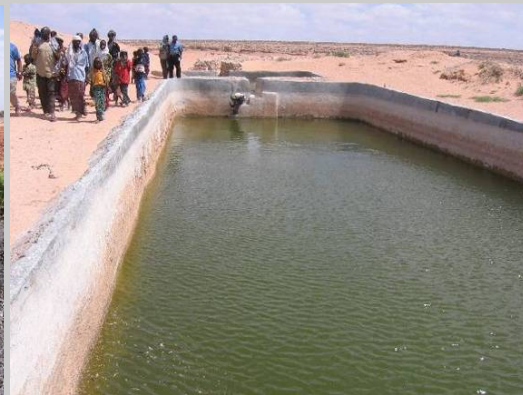
(a) *Berkad* at Ba'adwayn

(b) *Berkad* at Qarxis

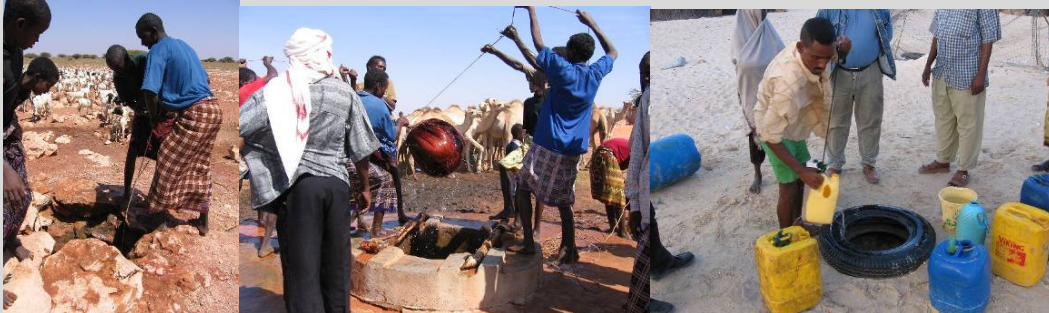
*Different types of shallow wells*

Modern technology has not yet been fully incorporated in shallow well construction in Puntland, with most wells being unlined and well heads unprotected. The majority of shallow wells are hand dug, making it difficult to penetrate hard calcrete and gypsum layers. Wells lack screens, tending to lower water quality depending on soil/rock types down the profile. In the deeper wells, well-sinkers are exposed to risks of loose boulders. In addition, failure to penetrate the water table to any great depths is a frequent cause of dry shallow wells during the dry seasons. Water extraction is mainly by bucket and rope, making water vulnerable to contaminants.

There is a need to adopt modern technologies for drilling, operation and maintenance of shallow wells. Detailed exploration such as the use of geo-electric or seismic soundings and use of experienced well sinkers should always be the starting point when establishing wells. Hand-digging of wells should also be replaced with machine drilling whenever possible, to ensure that sufficient depths of water are penetrated to ensure permanent water yield and safety of the well sinkers. Well construction should be standardized across the country, with more emphasis on hygiene standards. This would require covering of all water heads and the use of hand-pumps as a way of protecting the source from contaminants.

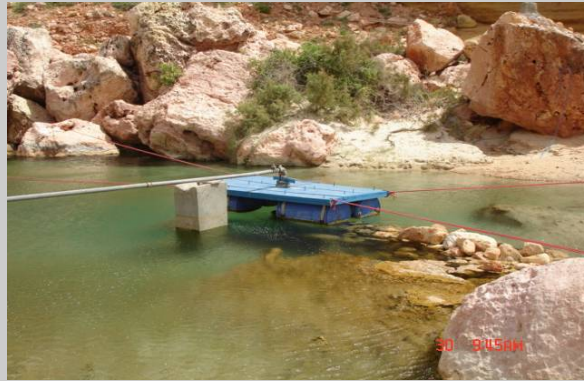
To alleviate the present and long-term needs for Falahfalah water supplies, mechanized pumping systems were constructed to utilize spring water resources in the town's vicinity. Spring water is expected to yield significant water for both domestic and livestock use. The system at Marayo is designed to lift 5 m<sup>3</sup>/hour of renewable fresh spring water for five hours a day. At peak times, Marayo's population is estimated to be about 120 households with 14.4 m<sup>3</sup> of water consumption per day. This leaves about 10.0 m<sup>3</sup> of water from the system for livestock. The exact numbers of livestock are unknown and they vary significantly with time.

*A typical spring at Marayo*

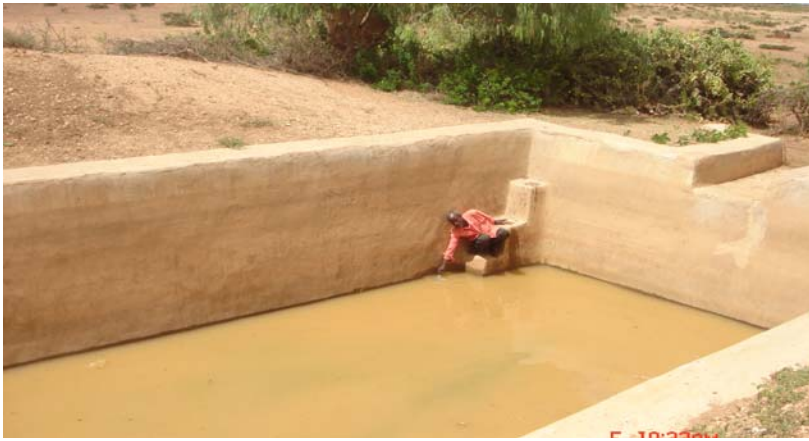
**Figure 4.1** Rectangular berkad with concrete wall

The *berkads* in Awdal and Galbeed regions are usually small, with a capacity of less than 300 m<sup>3</sup> while the majority of those in Togdheer, Sool and Sanaag regions are greater than 300 m<sup>3</sup>. Unlike shallow wells and boreholes, destruction of the *berkads* during the civil war was limited, especially in Sool region. Figure 4.1 gives an example of a modern *berkad* constructed with concrete.

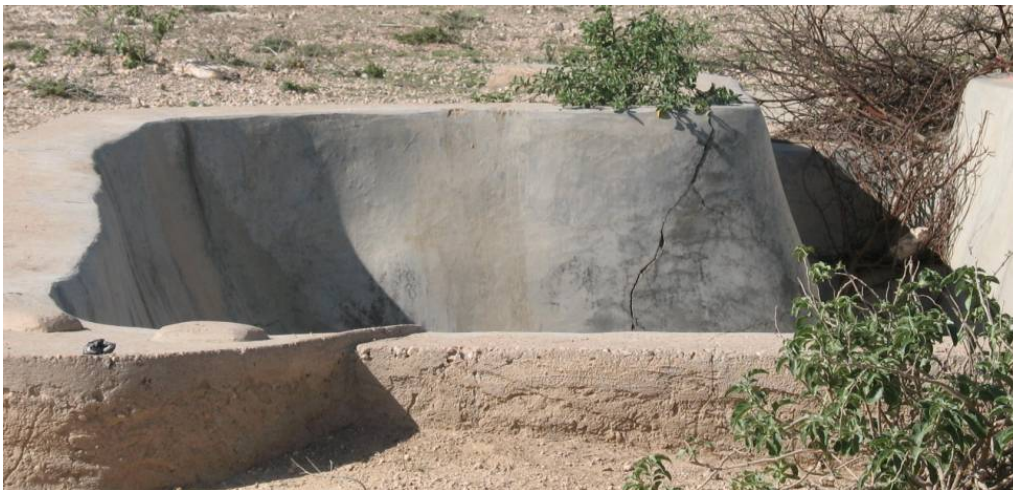
**Figure 4.2** Cracks on berkad wall

The rate of *berkad* failure is very high. It is reported that in almost all districts less than 50% of *berkads* are functioning. In an interview with GRC, it was noted that in Berbera District of Galbeed Region there are more than 300 broken *berkads*. Figure 4.2 shows cracks on a *berkad* wall, a common cause of failure.

Several factors contribute to *berkad* failure. GRC identified some of the common causes of failure as:

- Improving the masonry construction of *berkads* with strong foundations and proper joints. Circular *berkads* with reinforced walls have been found to last longer than rectangular *berkads*.
- Introducing roofed *berkads* to reduce evaporation, as well as curbing mosquito breeding and algal development. Currently, rural people are covering *berkad* tops with tree branches to reduce evaporation.

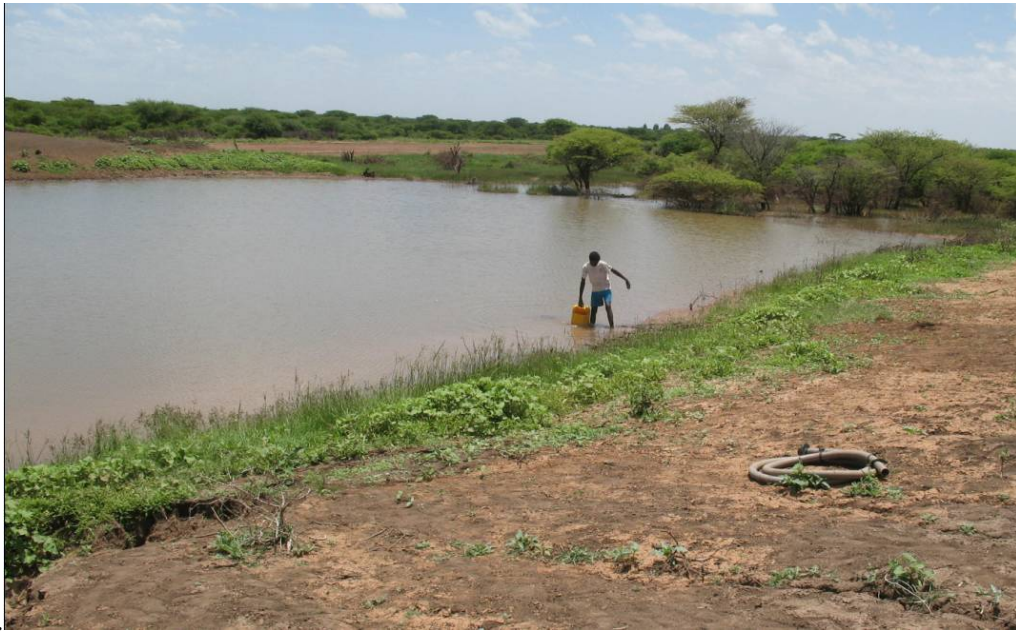
**Figure 4.3 Unhygienic water collection from a balley (dam)**

Six high capacity earth dams were built in rural Somaliland in the 1980s. Construction was funded by the World Bank to supply water for pastoralists along the Somalia - Ethiopia border. The dams had generator rooms, attendant rooms, animal troughs and kiosks. At present three of these dams are operational. Smaller capacity dams are also constructed, mainly by NGOs (see Figure 4.3) to boost water supply in rural areas. The SWIMS database shows that GRC have been working on 14 small dams in Awdal and Woqooyi Galbeed Regions, both in establishment and other interventions activities. One such earth dam constructed by GRC near Berbera is a major local supply. It connected to a well, which has a pump for water lifting. Before the establishment of the dam, water supply was very scarce in this extremely dry area.

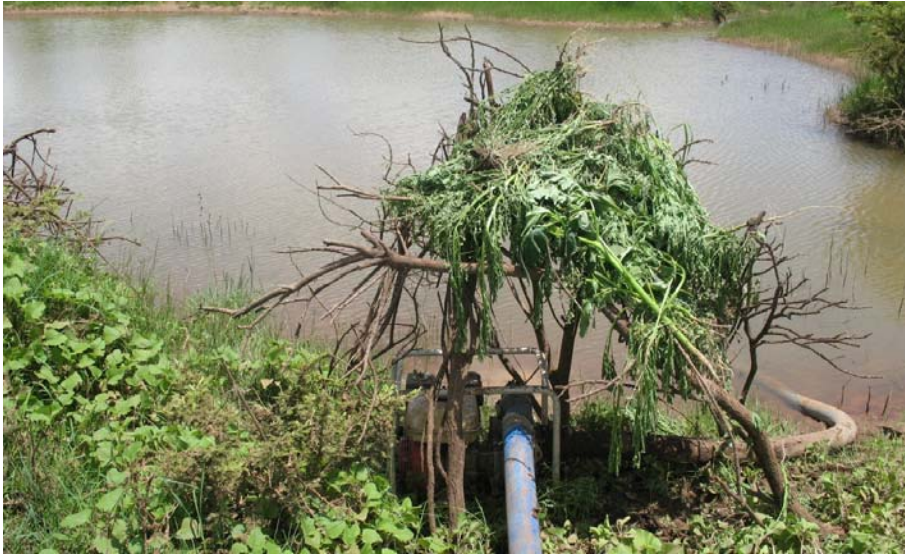
**Figure 4.4** Water extraction from a balley using a pump

The use of pumps to draw water from sources is also practiced, as shown in Figure 4.4. Pumps are either manual or run by an engine. In some cases a storage tank and distribution network are also available. The use of a closed system minimises the risk of contamination but increases the chances of over-exploitation of the water reservoir.

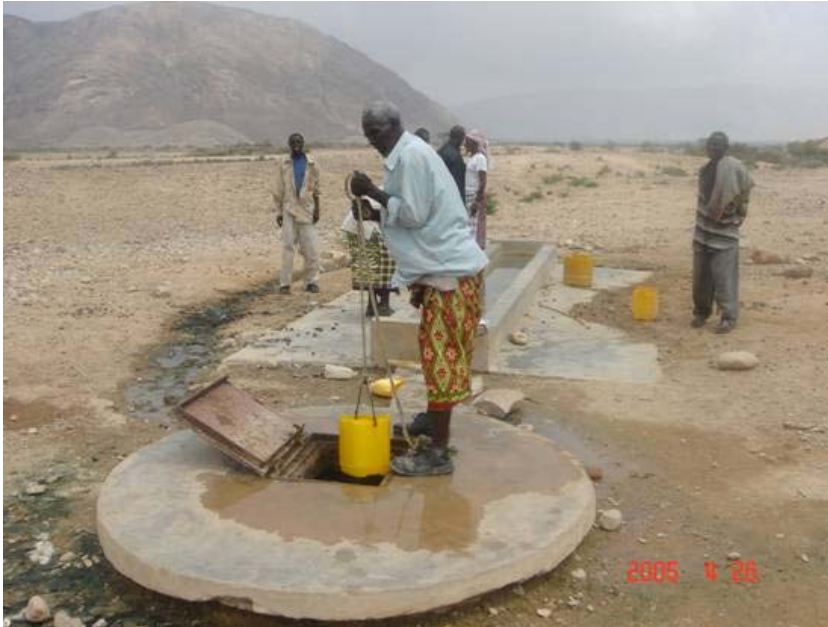
**Figure 4.5** Shallow well and animal trough

There are two types of shallow well found in Somaliland - those dug along the dry beds of seasonal rivers, and those dug or occurring natural away from river beds. Either type may be permanent or seasonal. In Figure 4.5 water is being drawn from a hand dug well using the bucket and rope method. Next to the well is a water trough for livestock.

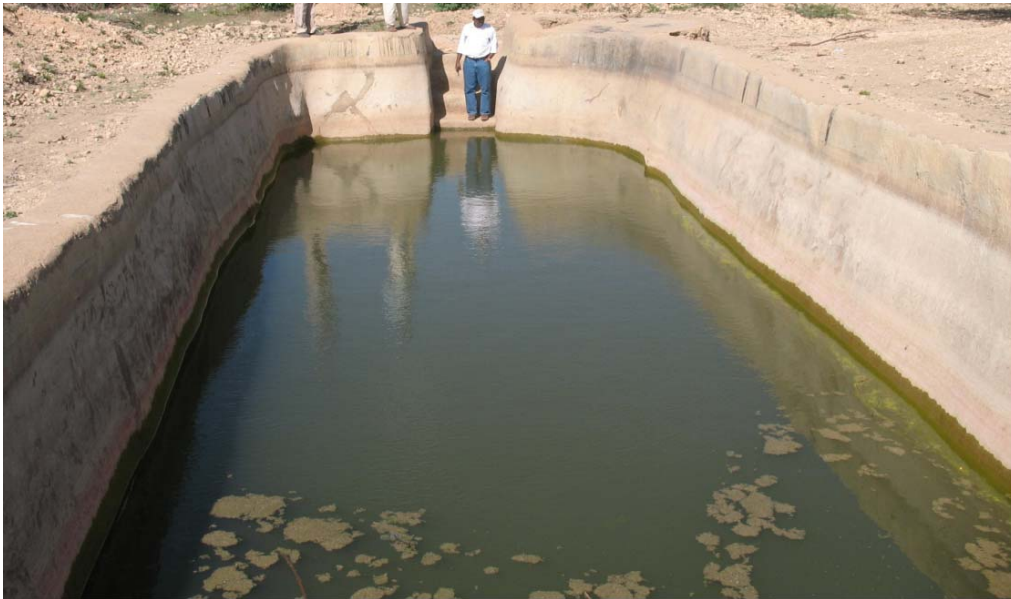
**Figure 4.6** Poor quality water in a berkad

The majority of the water sources in Somaliland are open, making them susceptible to all sorts of contaminations. There is no well organised system of checking the quality of water from these sources. In the whole of Somaliland, only one laboratory exists at the MWMR Hargeisa, the capital of Somaliland. Many of the *berkads* and dams are risk contamination from faecal bacteria. Figure 4.6 shows green-coloured water in a *berkad*.

To be able to meet the MDGs related to safe drinking water, many of the open sources need to be covered and installed with pumps for water extraction. Further, frequent water quality tests need to be performed on the water sources to determine the suitability of water for human and even animal consumption. This calls for consolidated efforts amongst the different stake holders to build the capacity for monitoring water quality and proper hygiene standards. SWISS Group introduced the PHAST training approach, which is reportedly successful.

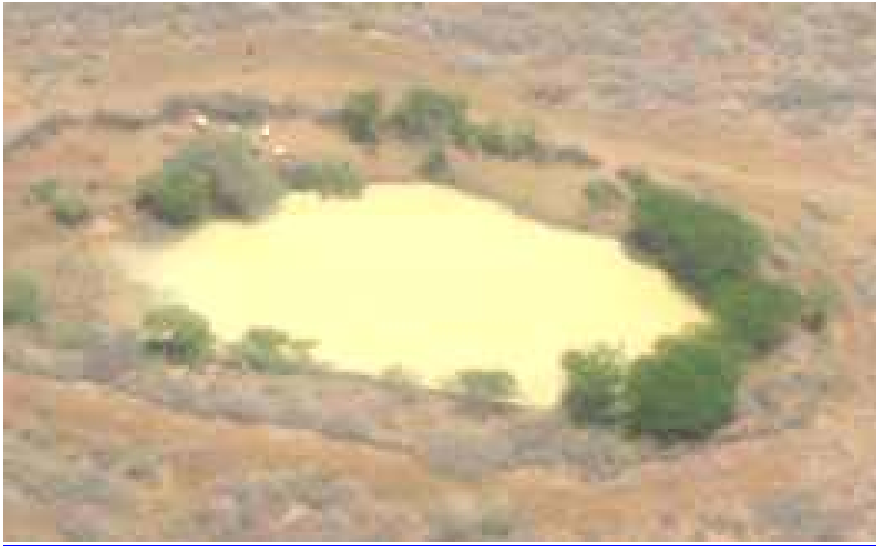
**Figure 5.1 War (dam)**

Clayey soils favour the construction of *wars* as shown in Figure 5.1. However, sometimes they have to be lined up with plastic sheets to prevent water loss through seepage. In cases where the source is lined, the storage period is known to increase by up to two months due to reduced seepage. The sizes of *wars* vary depending on manpower available in villages for their construction. Water can last up to six months, depending on the lining material and consumption rate.

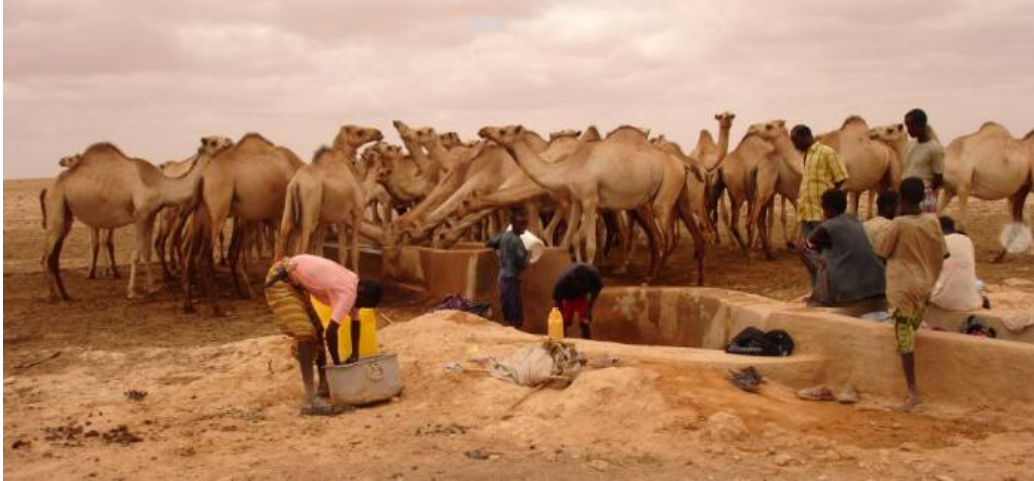
**Figure 5.2** Camels being watered next to a shallow well

Water quality is an issue for both surface and sub-surface water sources in South-Central Somalia. The sanitary condition of most sources in the region is generally poor. Water uses contribute to the sanitary condition of the source. Where water demand for livestock consumption is high, sanitation surrounding the water source is poor, with animal waste mixing with stagnant water at the watering point. Figure 5.2 shows camels taking water from a trough next to a shallow well.

Since many water sources are not protected, contaminated water eventually finds its way back to the well. The case is only different where the water source is used purely for domestic or livestock uses. Condition is also better at privately owned sources. Generally, traditional shallow wells used for both domestic and livestock consumption are noted as having the poorest sanitary conditions.
